Final Report

Environmental and Social Impact Assessment (ESIA) for Emergency Rehabilitation of Eleyele Dam, Oyo State

Submitted to

November 2016

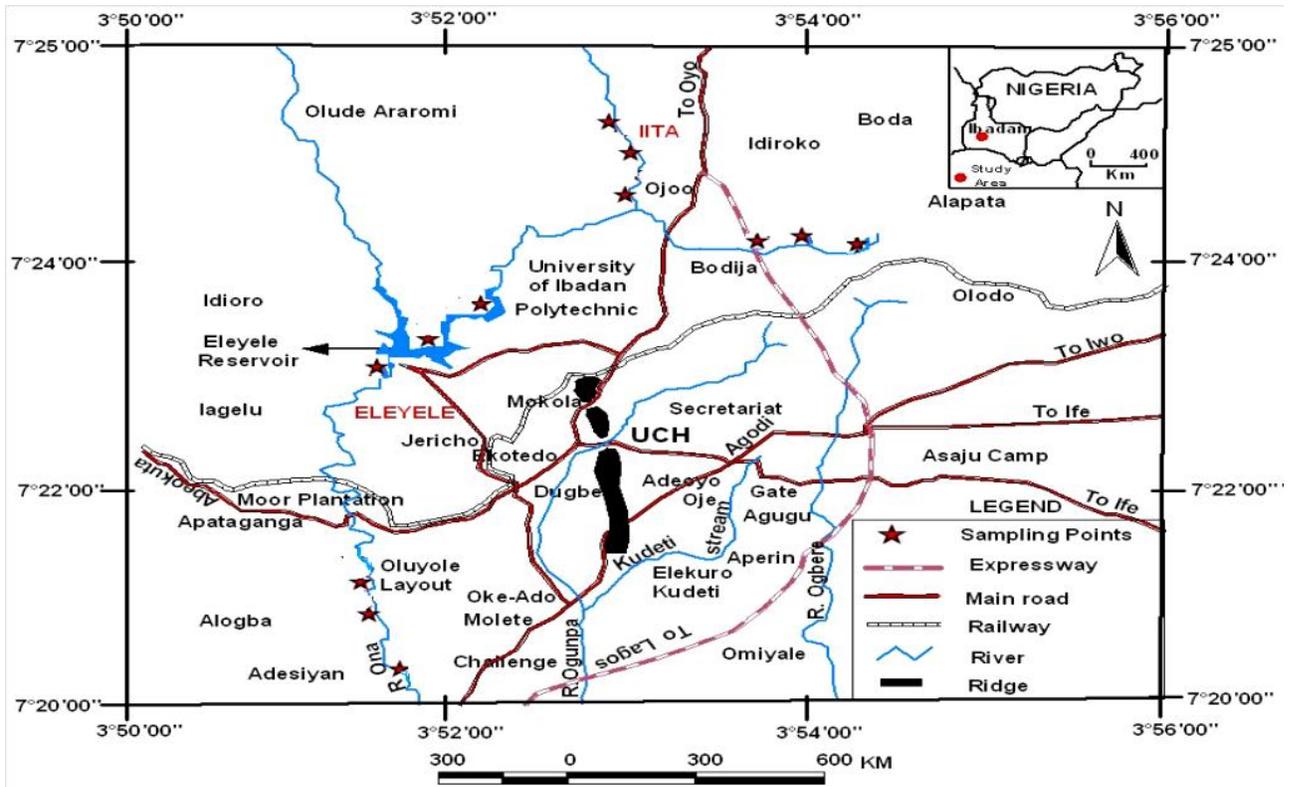
Figure 2.1: Eleyele Catchment Area

- Eleyele reservoir is located to the north-west of the Ibadan City centre bounded by Eleyele urbanisation in the south, the areas of Apette in the east, Awotan in the north and Ologuneru in the north-west.
- The catchment area of the reservoir is about 320 km² while the lake surface area is 160 ha and a fetch of 2.4km.
- The reservoir capacity of the Lake is 7MCM and the maximum reservoir yield is about 2700cu.m/day. The catchment area is shown in figure 2.1.
- The River is also abstracted by the Oyo States Water Corporation at Eleyele Treatment Works for treatment and supply of potable water to Ibadan's people.
- The surrounding area of the reservoir is made up of light forest with a wetland margin around the perimeter of the lake.

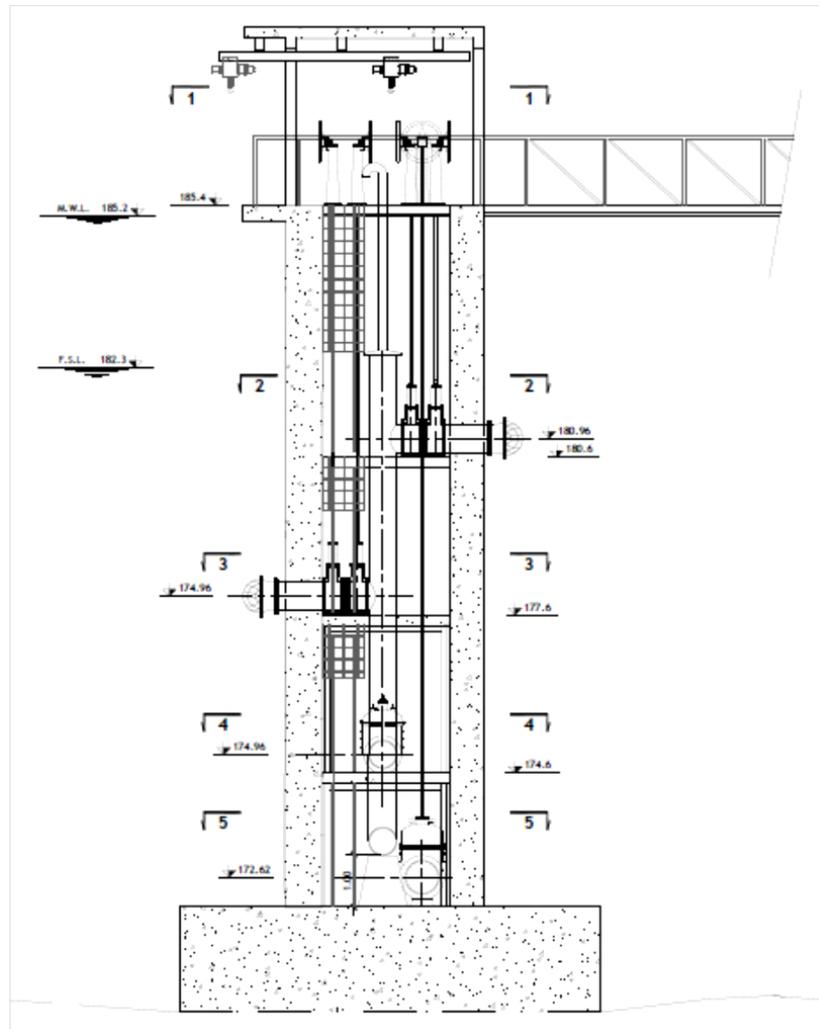
Figure 2.2: Illustration of Rehabilitated Intake Tower

- The objective of these three levels of intake is to always take the best quality of raw water (in term of turbidity and suspended matters
- He intake tower also protect the dam in case of imminent failure of the dam to rapidly lower the water level. The bottom outlet valves are used in this case to rapidly empty the reservoir

- The intake tower is not equipped with any electrical equipment (no light, no sensors, and no electrical actuators on valves).

An illustration of proposed rehabilitated intake tower is presented in figure 2.2.

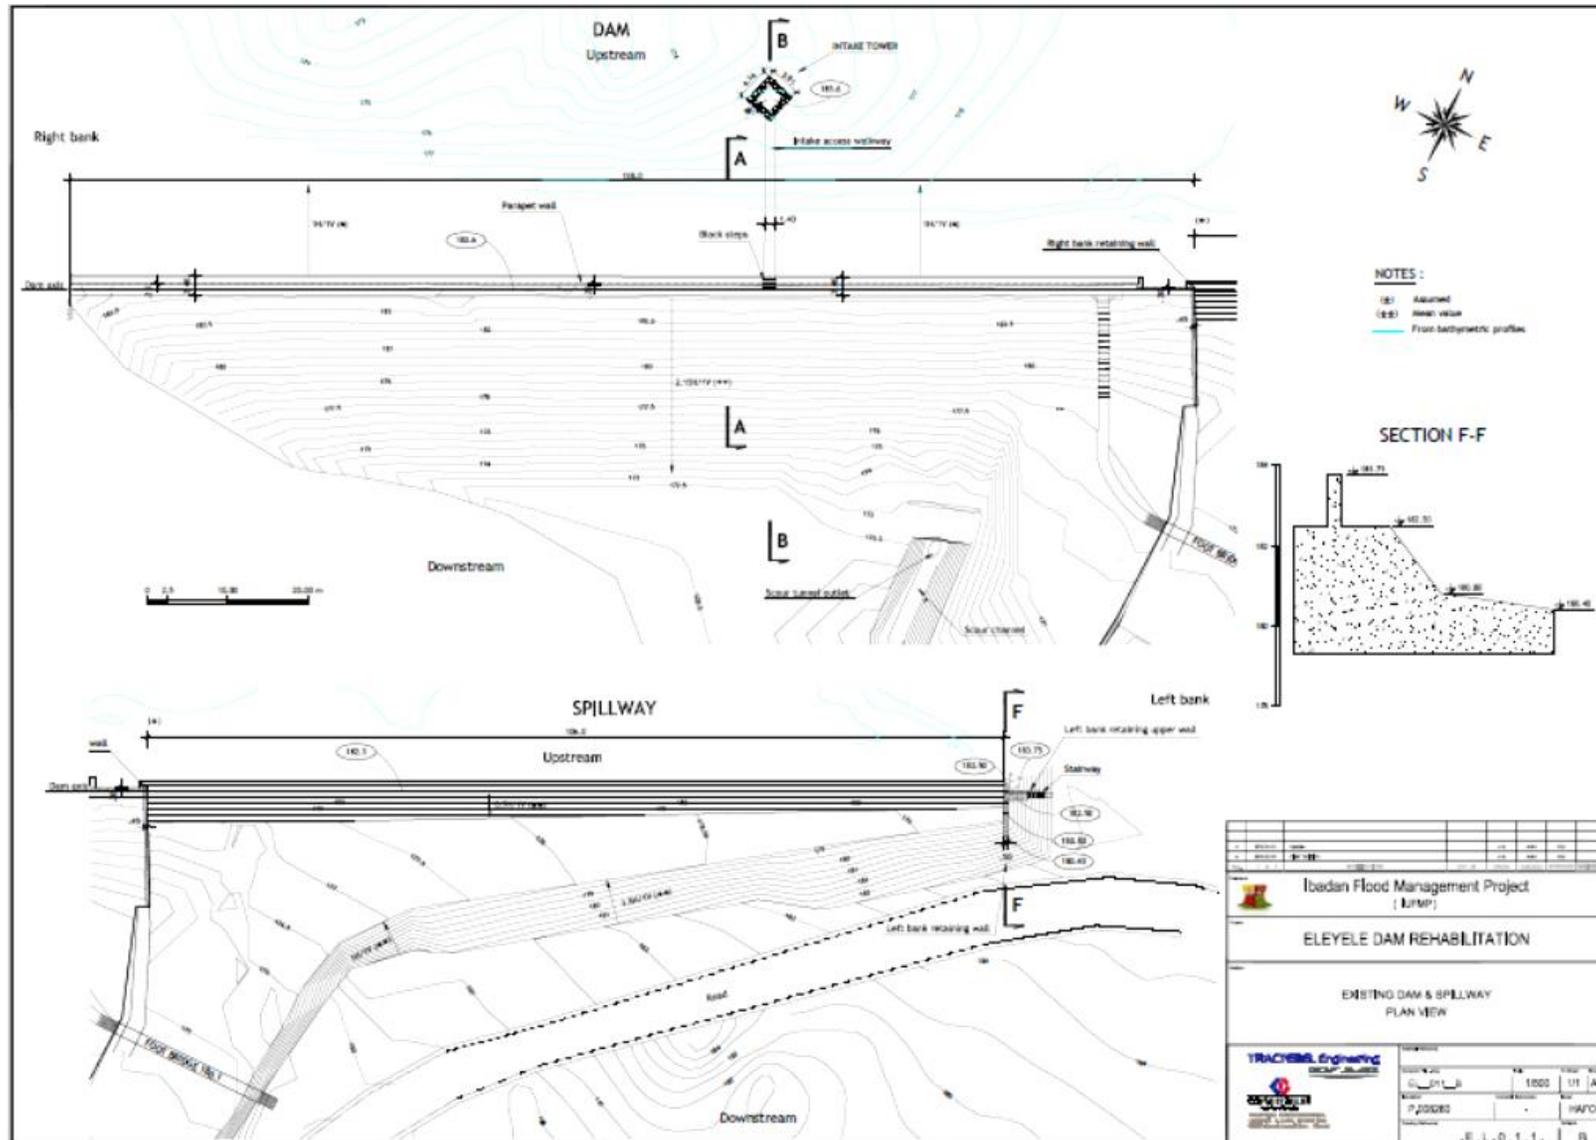
Figure 2.3: General Layout of Eleyele Dam Proposed Rehabilitation Project-Plan View

- The Eleyele reservoir on Ona river;
- The Eleyele dam;
- The water intake structure upstream of the dam embankment equipped with gates and their operating systems;
- The tunnel under the embankment functioning for flushing sediments (scour tunnel) through which the draw-off pipe to the treatment plant runs;
- The 106 m long and 13 m high free overflow lateral concrete spillway;
- The lateral concrete spillway chute channel which receives and returns the overflow to the Ona River through a series of concrete steps;
- A return channel joining up the tunnel with the river.

The proposed rehabilitation project of Eleyele dam is presented in figures 2.3 and 2.4.

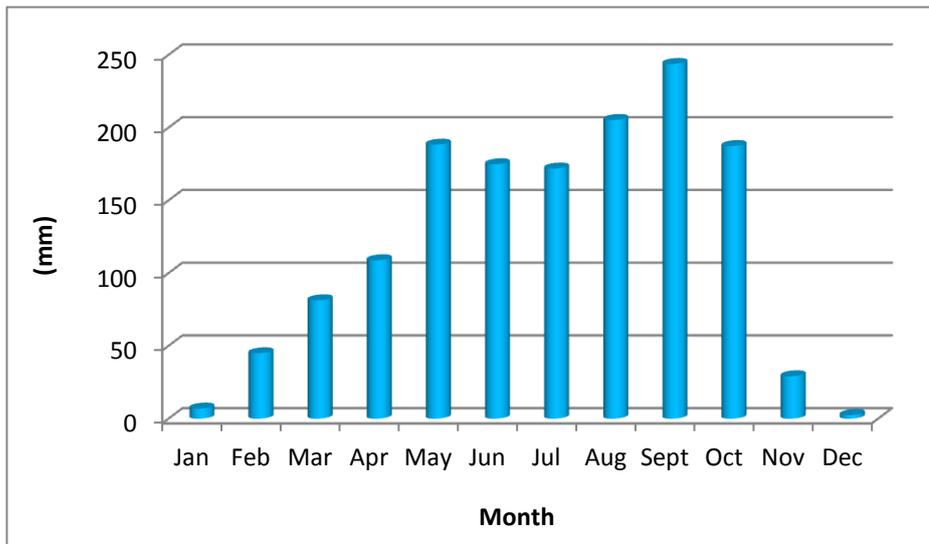
Figure 3.1: Rainfall Characteristics of the Study Area

Of the two seasons identified: the rainy season (April to October) and the relatively dry season (November to March) with an annual average rainfall of 120.5mm, only the months of December and January truly qualifies as dry season months in the area (Figure 3.1). Rainfall pattern shows two rainfall peaks in May and September, Rainfall is heaviest during the months of August and September.

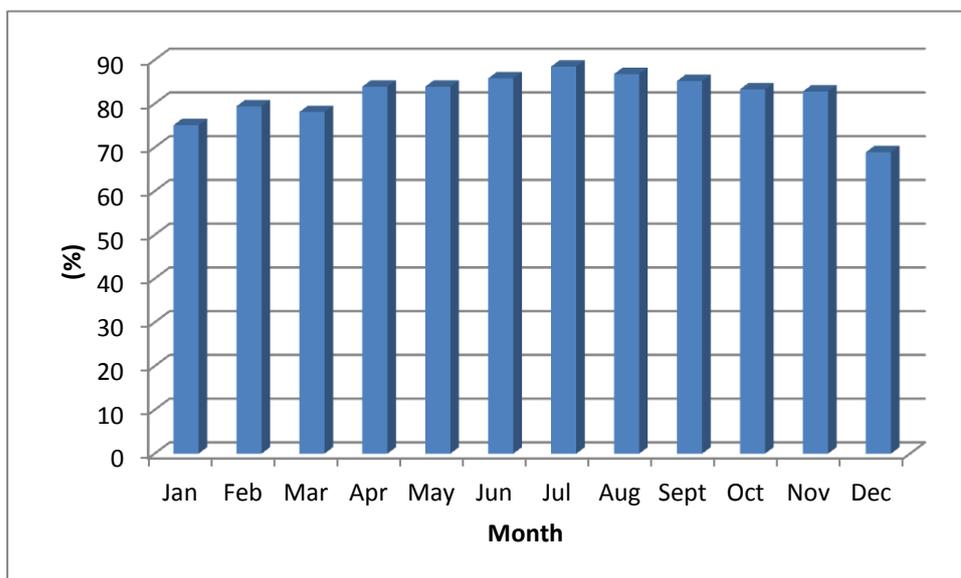
Figure 3.2: Relative Humidity at the proposed project area

Relative humidity (RH) in the study area was observed to be relatively constant ranging between 68.9-88.5% at 09:00 Hrs with an average of 81.8% (Table 3.3). The relative humidity in the area is lowest in the months of December to March, while the maximum levels are within June-September (Figure 3.2). The measured relative humidity of 58.6 – 78.9% with an average of 67.2% at 9:00 Hrs recorded during the fieldwork (Table 3.2) compare with the data provided by NIMET on project area for the month of March.

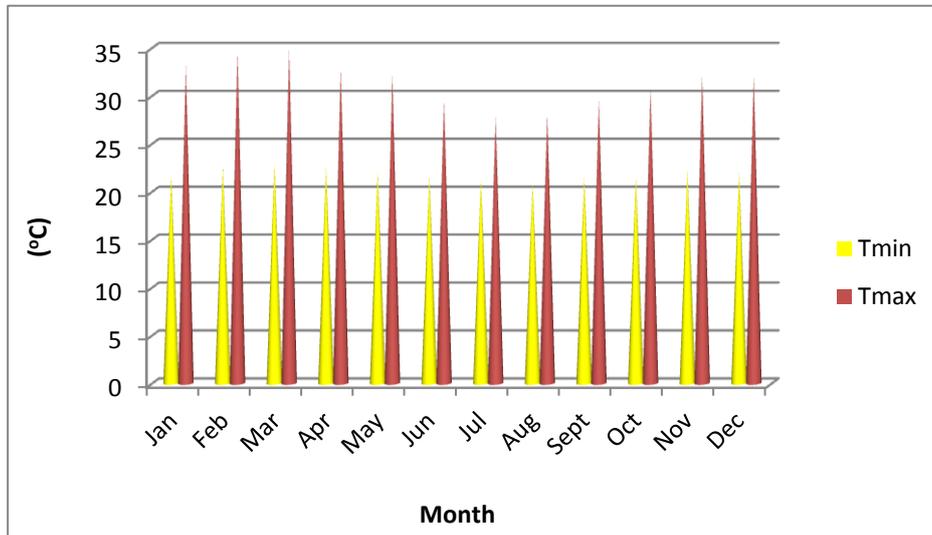
Figure 3.3: Temperature characteristics of the Study Area

The monthly average temperatures ranged between 20.9-23.0°C for minimum temperature and 27.8-34.8°C for maximum temperature, while the mean yearly minimum and maximum temperatures were 22.0°C and 31.4°C respectively. The lowest temperatures were recorded in the

months of July and August while the highest temperatures were recorded from November to April (Figure 3.3). During field survey, the atmospheric temperature range of 29.7-35.3°C with an average of 32.6°C was obtained which compares with the available temperature data of the study area.

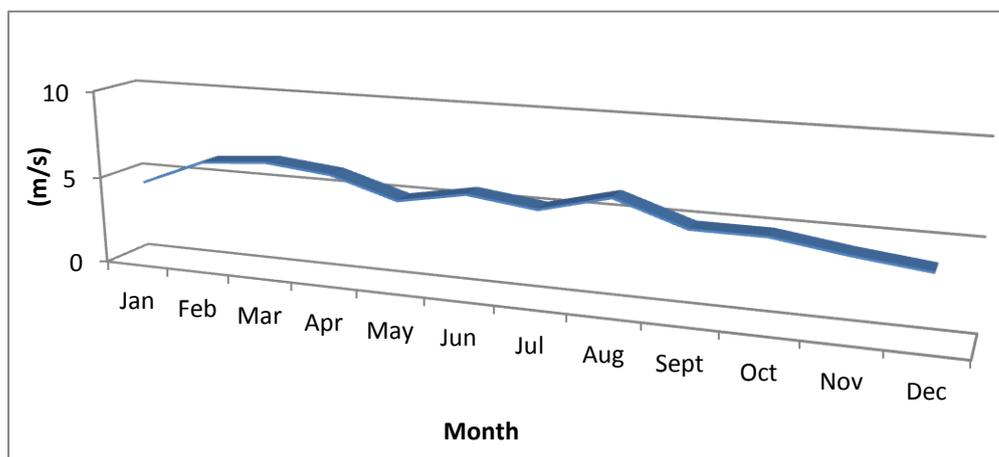
Figure 3.4: Monthly Average Wind Speed around Study Area (2005-2014)

The surface wind data distribution of the Study area gives an average range of 3.76 – 6.39 m/s. Wind distribution pattern for the study area shows that the wind predominantly blows from the south-westerly (SW) direction (about 63% of the time). Other prevailing wind direction was from the westerly (W) direction and southerly (S) direction.

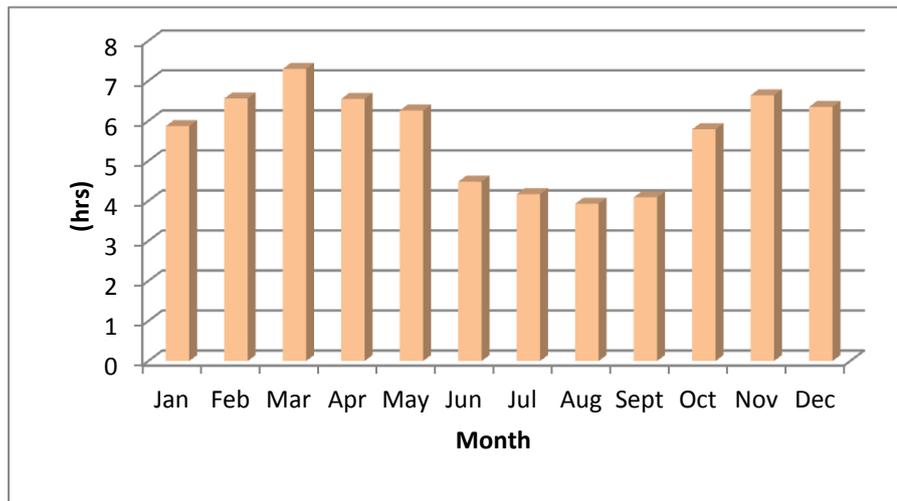
Figure 3.5: Average Monthly Sunshine Hours around Study Area (2005-2014)

The study area receives a monthly average sunshine of 3.93– 7.30 hours per day with an annual average of 5.67 hours. It receives its longest sunshine period between November and May with March recording the longest sunshine duration of 7.3 hours, while shortest sunshine duration is recorded between June and September (Figure 3.5).

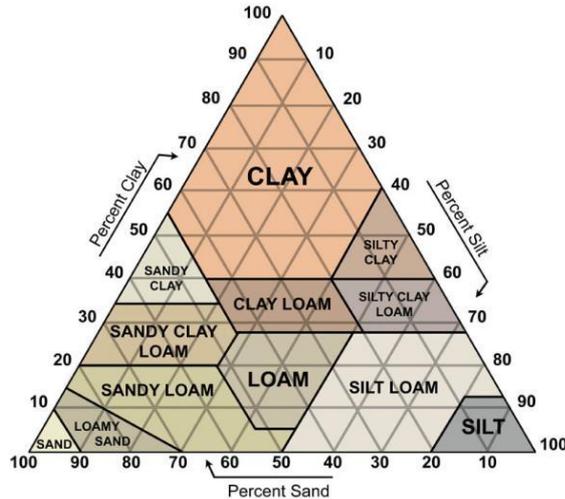
Figure 3.6: USDA Soil Textural Triangle

From the soil textural triangle in Figure 3.6, the soil around the project area could be classified as sandy clay loam.

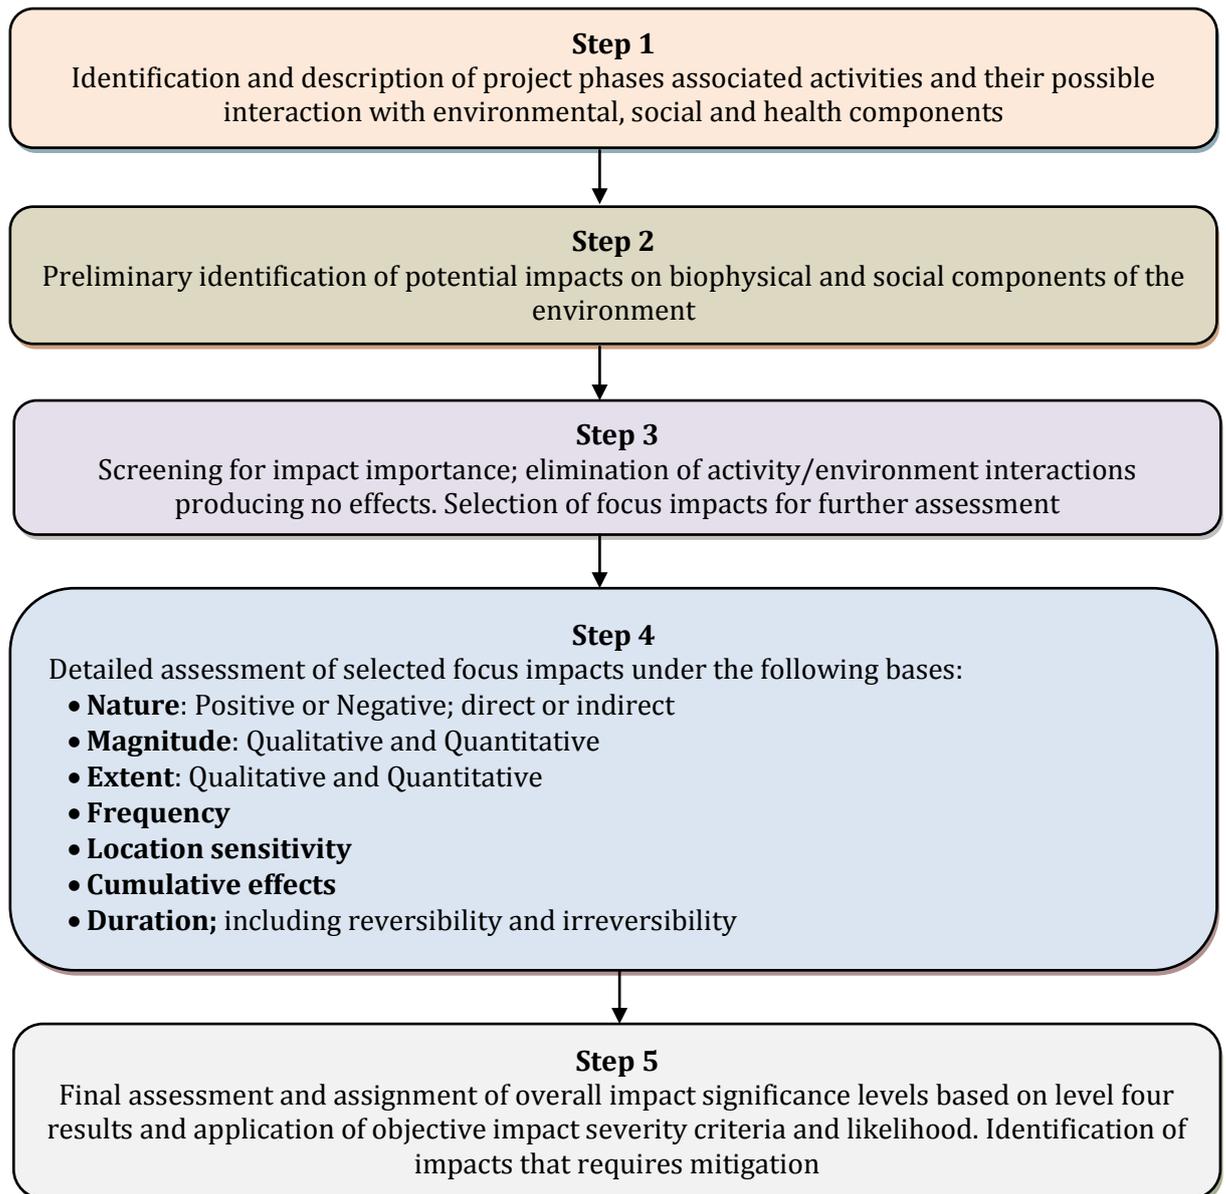
Figure 5.1: Schematic of the Impact Assessment Methodology

The approach adopted in this impact assessment was geared towards addressing both requirements. The methodology used for the proposed dam rehabilitation is summarized in Figure 5.1.

- Superimposing project components on existing environmental conditions to identify potential impact areas and critical issues;
- Field investigations;

- Consultation with experts, stakeholders and nearby residents;
- Development and maintenance of a comprehensive database on the biophysical and socio-economic characteristics of the environment of the project area;
- Experience from similar projects;
- Discussions with project proponents and design contractors;
- Published and unpublished documents providing guidance on performing impact analysis.

Each of the above approaches has merits and demerits. In order to comprehensively assess the impacts of the proposed dam rehabilitation project, relevant methods were combined systematically at various steps of the assessment process (Figure 5.1).
